**SPECIAL MEMBERS' MEETING**

**Wednesday, February 28, 2024 at 7:00 pm**  
**Meeting held at Hillary House NHS**  
**and Virtually via Zoom**  
**MINUTES**

## **CONDITION ASSESSMENT REPORT**

# HILLARY HOUSE

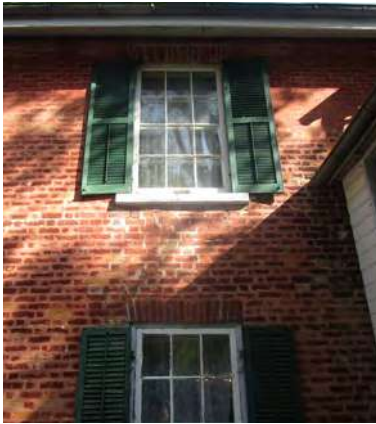
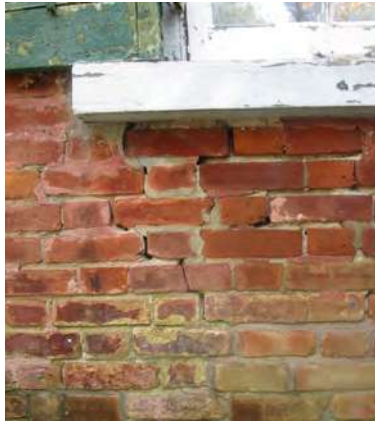
While the brick masonry at the south elevation of the original house is in similarly good condition to that of the east, the south brick wall that is part of the 1869 addition to the house displays issues. The foundation under this portion of the house was excavated after its initial construction to allow for coal delivery and storage, and the excavation for the adjacent under-porch passageway may have caused some soil settlement. It is expected that the resulting foundation

Left: South elevation of 1869 Addition.  
Right: Structural cracking beneath 1st story window at south elevation of 1869 addition.  
(ERA, 2017)

movement contributed to the structural issues in the brick, but was perhaps exacerbated by subsequent water penetration. It is clear that the wall has been repaired many times, as several different mortars are visible in the brickwork. Some of areas have been repointed using cement based mortar, which can cause deterioration of the brick units themselves. The major issue with this wall is a structural step crack which runs up the full height of the wall at the west side of the window bay. In addition to the earlier mentioned historical disruptions to the wall, inadequate or deteriorated lintels at the window openings could have contributed to this condition. The wood windows and sills at this wall exhibit peeling and deteriorating paint.

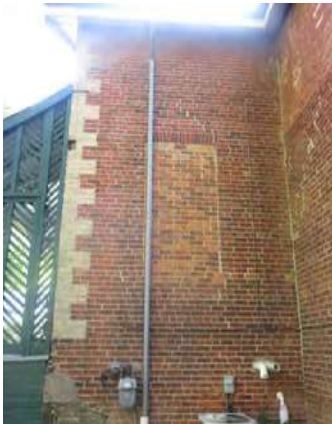
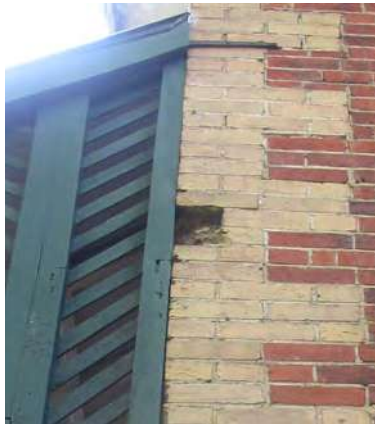
Left: West facing elevation of main house.  
Right: Missing brick units at this elevation.  
(ERA, 2017)

The west facing elevation of the original house is in generally fair condition. The mortar is relatively sound and intact, with some isolated areas of deteriorating or missing mortar visible. Previous repairs seem to have been effective, although there is some cement based mortar present. There are several small holes to be filled in the brickwork, and a small number of missing or damaged brick units. The condition of the west face of the rear kitchen addition will be discussed in a separate section.

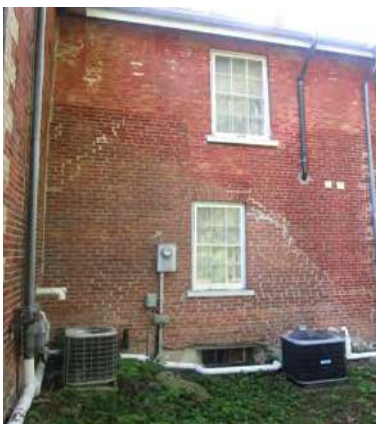
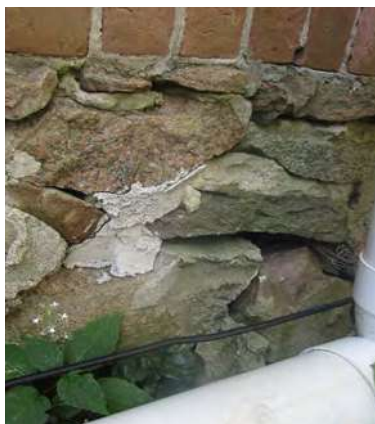
Left: North elevation of 1869 addition  
Right: Detail of deteriorating foundation at north elevation.  
(ERA, 2017)

Similar to the south elevation, the masonry at the north of the 1869 addition is in poorer condition than that at the original house, but the condition of the brick is better than at the south, as this wall has received less foundation disturbance over its history. It has been visibly modified, however, where a second story opening was infilled and a slightly offset window introduced in the ballroom. This infilled area marks the top of a large step crack that runs down toward the west portion of the wall, some of which has been repaired with an unsympathetic cement based mortar. The condition of the mortar in general on this wall is fair, with some local areas exhibiting missing or deteriorated mortar in the joints. Minor holes are scattered along the wall closer to grade, and there are a number of spalled units at the upper part of the wall. While much of the foundation wall at this elevation is unexposed, the visible portion at the west side of the wall displayed significant deterioration, with a total loss of mortar in multiple locations. The settlement in this area is likely contributing to the structural cracking observed up the wall to the east. The condition of the rear kitchen addition will be discussed in a separate section.

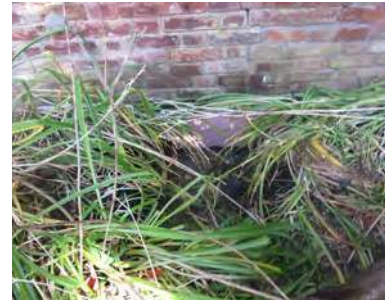
Depression in ground by site of former coal chute at south elevation. (ERA, 2017).

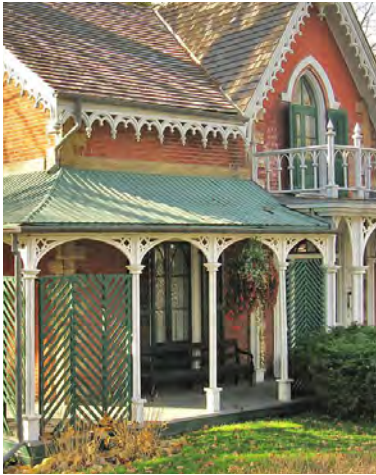
Portion of east veranda where firmness issues are present in the floor. (Wikimedia Commons).

The veranda floor exhibited sponginess and minor deflection in some of its floorboards. This was reported primarily at the east elevation in front of the consulting room doors, and at the north veranda facing the lawns, although deflection was also observed at the south elevation at the top of the veranda steps.

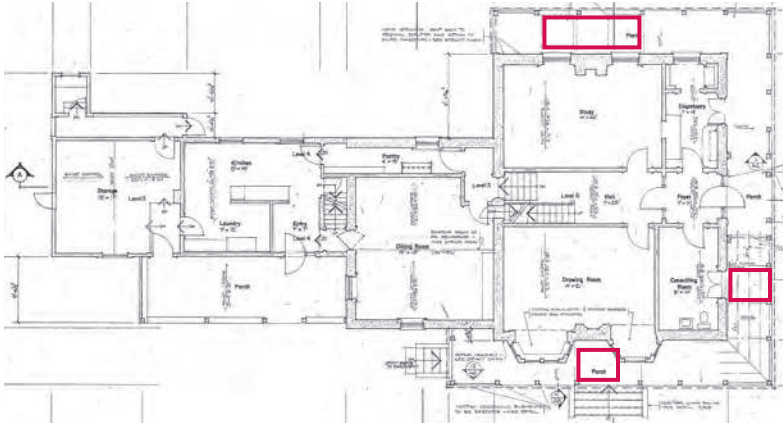
Plan of ground floor, with areas of concern at porch floor highlighted in red. (Goering, 1982. Annotated by ERA, 2017)

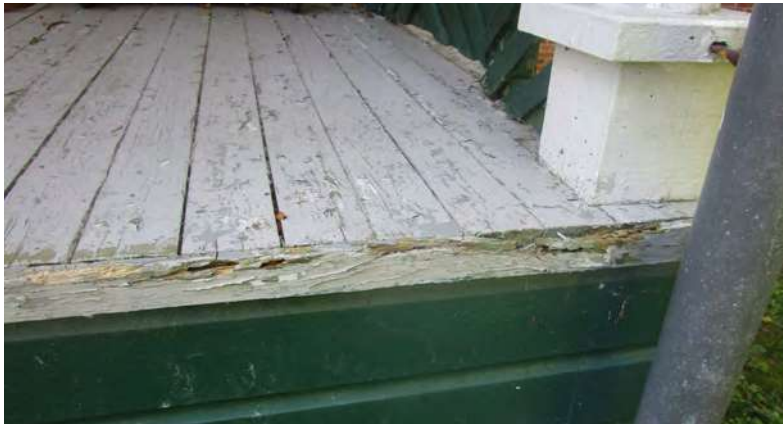
Deteriorating woodwork at Veranda edge. (ERA, 2017)

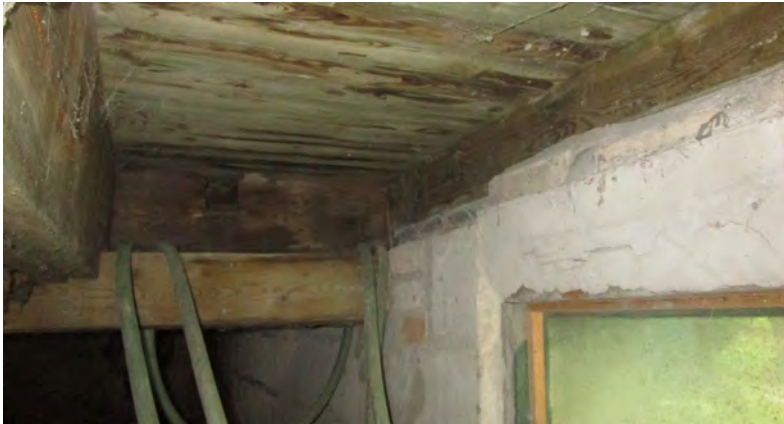
Underside of south veranda floor at area of concern, showing the wide span made by the floorboards in the area at the top of the steps.  
(ERA, 2017)

In addition to the areas reported above, there was also minor deflection observed in the floor at the top of the south veranda stairs. The joists in this area received reinforcement with new beams during previous remedial work, in addition to new decking and ledger boards, as at the east. The concrete block wall at the edge of the veranda in this section (which is also the sidewall of the passage underneath the veranda) was noted as being deteriorated in a 1999 structural assessment report. The wall has subsequently been repaired and reinforced with steel plates and anchor rods to assist in the retention of the soil beyond. The crawl space passage underneath this section of the veranda provided an opportunity for review of the underside of the porch structure. While the condition of the wood framing and repaired block wall appeared good, it is possible that the settlement and subsequent remediation of the block wall caused a loss of fit or alignment in some of the wood structural members, contributing to a lack of firmness in the decking. Worthwhile to note is the span of the floorboards in the area of the veranda at the top of the stairs. While Morrison Hershfield's 1980 structural drawings show existing double floor joists at a maximum of 21" spacing in this area, the floorboards as observed are spanning over 30" from the south masonry wall to the mid span joist. This large span may be contributing to the firmness issues at the porch in this area.

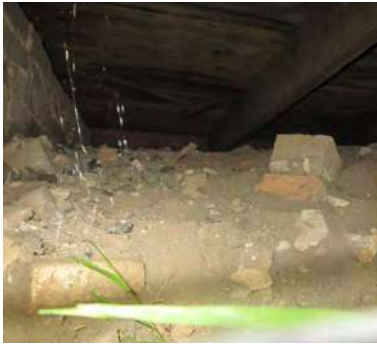
Underside of rear kitchen addition floor, with broken floorboards visible. (ERA, 2017)

it was observed below the cladding that the brick foundation wall at the west does not return and connect back to the assumed foundation wall at the east of the addition, compromising the stability of the wall. The resulting opening below the cladding at the south (as well as many other cracks and holes about the addition) was covered with wire mesh. Observing the floor structure through this mesh covered opening, several deteriorated and broken floorboards were visible.

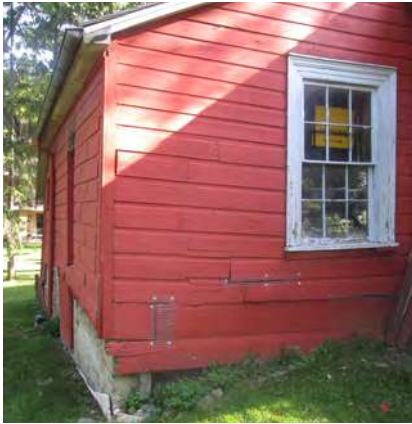
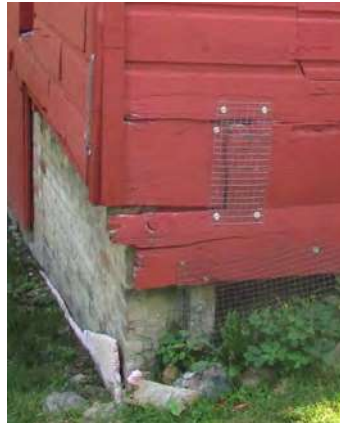
The south elevation of the addition displays a sag in the wood cladding, where shifting structural members have caused the seams between boards to come out of alignment and apart. At the foundation level,

On the whole, it appears the rear kitchen addition has suffered from foundation settlement and movement, which is forcing the wood framing above out of alignment, and straining their connections. It is possible the foundations in this area are not of adequate depth to prevent frost heave issues, or are not bearing on a solid footing. They are also discontinuous, and lacking in proper integration with each other to achieve greater stability. While previous repair is still sound and intact, it is a local effort, and the quality and depth of the footings for these repaired portions is unknown.

Left: South elevation of rear kitchen addition  
Right: Detail of rebuilt west foundation wall that does not return at south.  
(ERA, 2017)

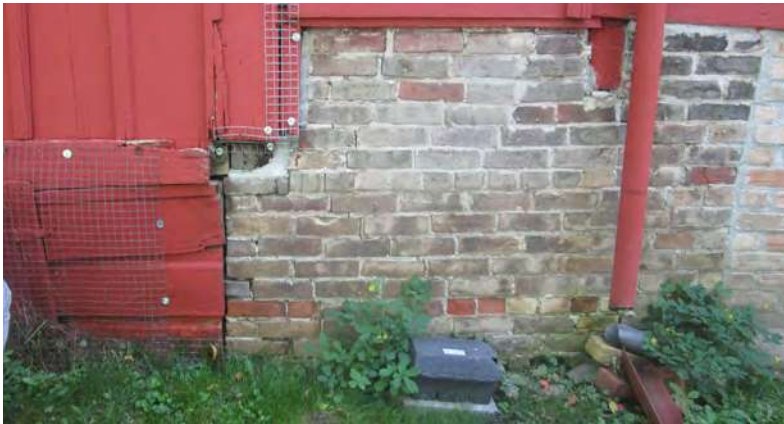
The foundation area (below the wood cladding) at the west elevation of the addition has seen some repairs. At some point, the southernmost portion of the brick wall was rebuilt, and brick piers were constructed to form the crawlspace at the center of the addition which is accessed from the exterior. The foundation depth and footing of these newer brick elements is unknown, but they appear fairly stable. Investigation in the central crawlspace found the brick piers to be supporting widely spaced 2x6" joists. The floorboards of the addition were not fitted tight against the joists, with most showing either shimming or gaps. The section of foundation brickwork to the north of the crawlspace is older and in poorer condition, exhibiting step cracking, deteriorated mortar joints, and cracked units.

Brick Foundation Wall at north portion of west elevation of kitchen addition.  
(ERA, 2017)

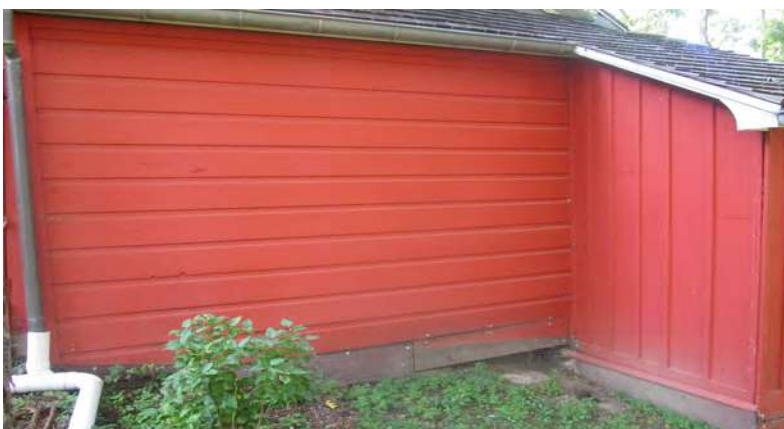
At the north of the addition is a semi-independent structure comprising the privy and the corridor leading to it. At the exterior, it appears to have a separate foundation system from the main addition, as the brick wall at the north terminates at this portion. Gaps in the skirt beneath the cladding showed that there was no visible continuous foundation wall. Significant deterioration of the floor joists at this north portion was visible through small openings in the skirting.

North elevation of rear kitchen addition, showing corridor and privy structures.  
(ERA, 2017)

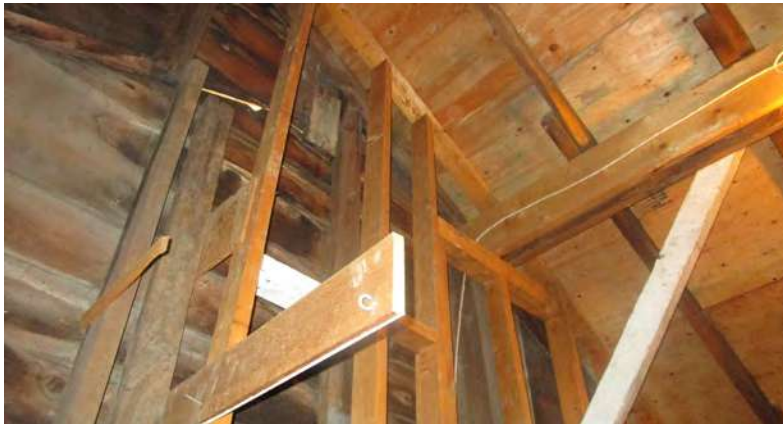
Remediation of framing at the interior of the rear summer kitchen addition.  
(ERA, 2017)

The framing above the floor level, visible from the interior of the addition, shows evidence of previous repairs. The oldest framing visible is rather sparse 2x4" construction. Newer 2x4" back-up stud walls have been constructed within the older walls to support the roof close to the south gable. While the older 2x4" spliced rafters remain, there has been newer roof sheathing installed. Additional bracing and supports have been installed throughout. It is assumed this repair and remediation was introduced in response to issues in the wood framing resulting from foundation settlement.

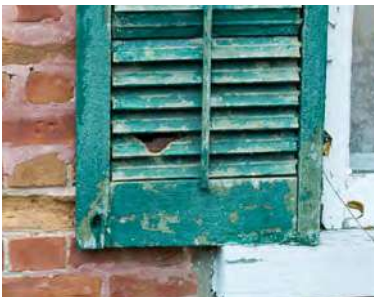
Wood shutter has been chewed, allowing access to a hole in the masonry. (Hillary House National Historic Site, 2017).

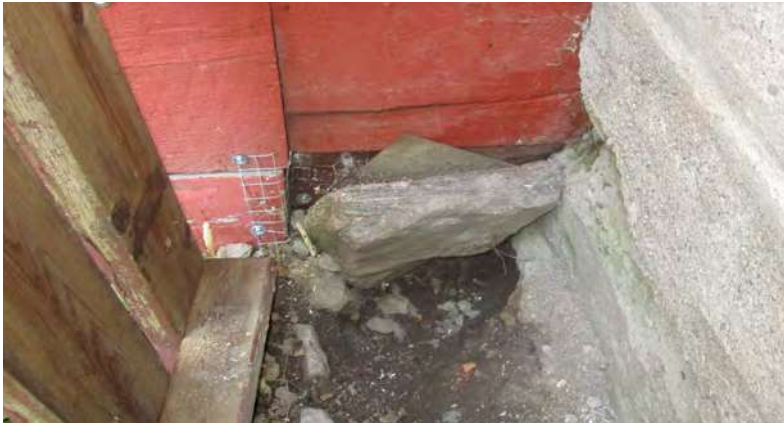
Animals may also be entering the fabric of the 1888 addition area through the eaves of the roof. Upon inspecting the attic at the top of this addition, it was observed that the batt insulation at the ceiling joists was disturbed, especially at the eaves, and there was some evidence of animal traffic. As there was a considerable amount of daylight visible in the attic at the eaves, it is assumed that there may be unchecked points of entry about the perimeter.

Potential point of animal entry at south portion of rear kitchen addition. (ERA, 2017)

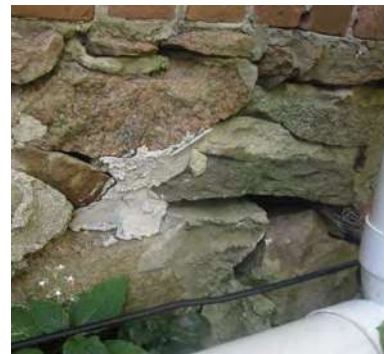
Detail of deteriorating foundation at north elevation of 1869 addition. (ERA, 2017).

1. Regrade around the perimeter of the house, ensuring slope is away from the house. Provide river-rock buffer at edge of house,
2. Excavate around existing fieldstone foundation to a depth of 600mm below grade. Repoint 100% all visible fieldstone and apply parging finish. Replace deteriorated stone units as required. Provide one (1) test pit down to footing of brick foundation.
3. Remove skirt and/or floorboards at deteriorated areas of floor on the east and north veranda to inspect for deterioration of structural members. Repair or replace severely damaged structure as required to make safe. Prepare, prime and paint.
4. Install new joist(s) at the south veranda between the southernmost existing joist and the block perimeter wall. Inspect all floorboards and structural members for deterioration and stability. Repair as required.

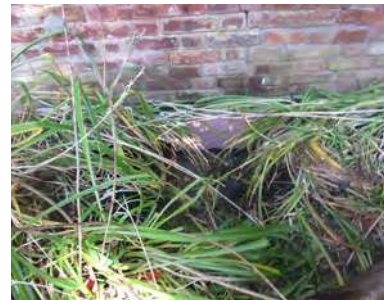
Depression in ground by site of former coal chute at south elevation. (ERA, 2017).

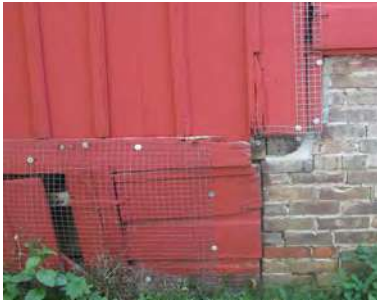
Area for review and repair of wire mesh at rear kitchen addition. (ERA, 2017).

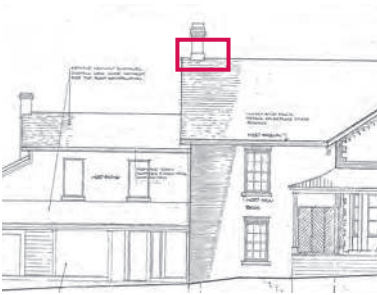
Location for inspection of flashing at western chimney. (Goering, 1982. Annotated by ERA, 2017).

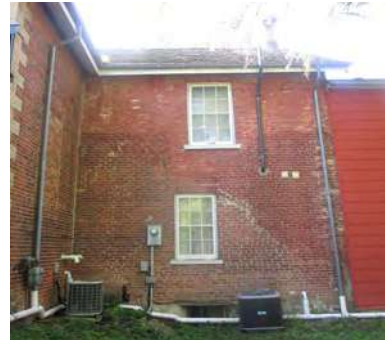
Masonry for review at North elevation of 1869 addition. (ERA, 2017).

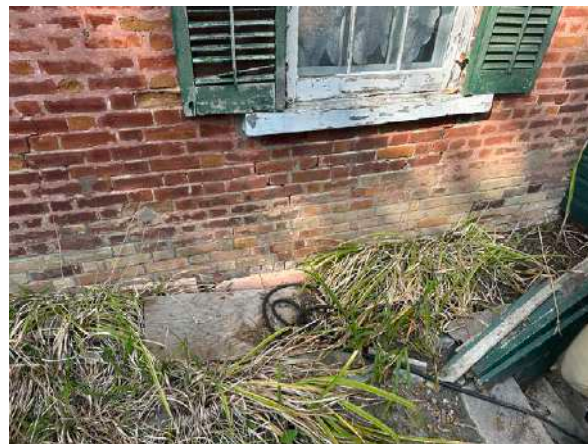
Foundation at South elevation of ball room, closed-off crawlspace venting.

ERA maintains the 2017 recommendation to excavate masonry foundations at the north, south and west elevations of the 1869 addition to inspect for deterioration and repair as required. Repair work would include removal of cement mortars, repointing, brick replacement, patching of holes and stitching of cracks, as well as repair of foundation issues from test pit investigation. See item 2.3.2 Foundation Damage on Main House for further information. (Item 11)

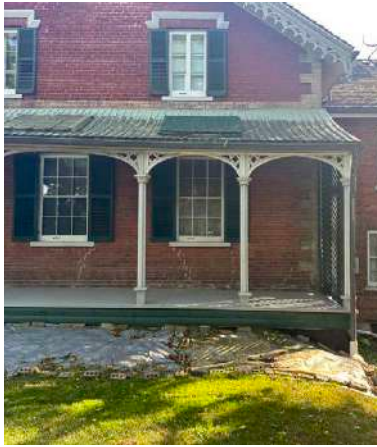
North Verandah missing stairs to tennis court.

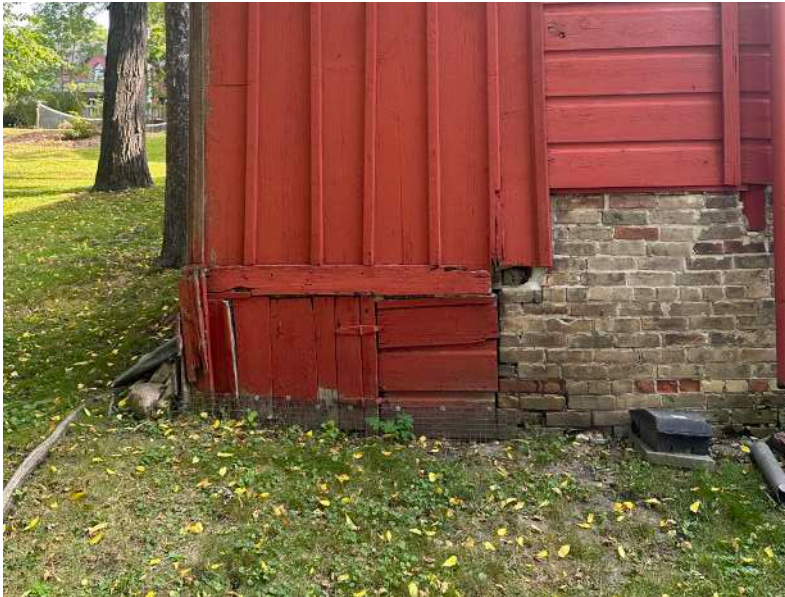
Animal Ingress routes through the summer kitchen north-west corner which have been partially addressed with chicken wire, and traps. Note, significant amounts of skat present in outhouse. (ERA, 2023)

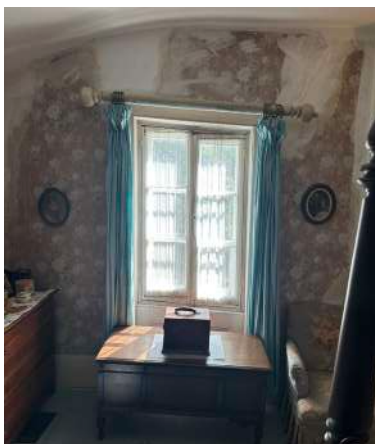
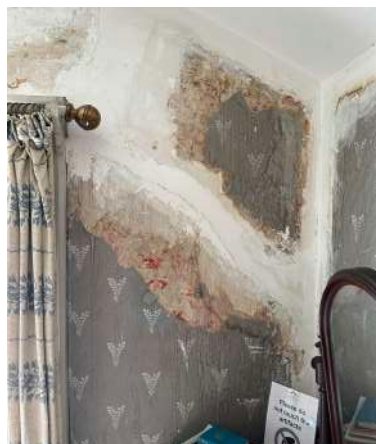
At the time of the visit the condition of the wallpaper in second floor bedrooms appeared to be unchanged since 2017. Refer to Conservation recommendations in 2017 report. The associated cost of the investigation is carried over in the cost analysis.

Deteriorations of wall paper with emergency plaster repairs in bed rooms on second floor. (ERA, 2023)

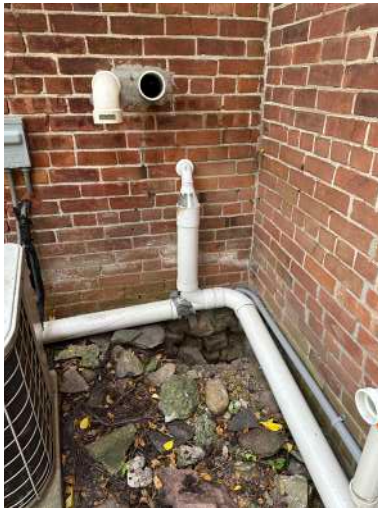
Rupture at PVC pipe with wash-out of backfill at foundation.

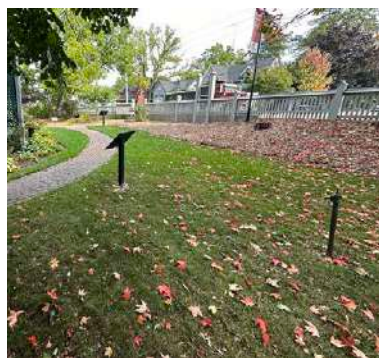
Landscape grading towards east elevation of house.

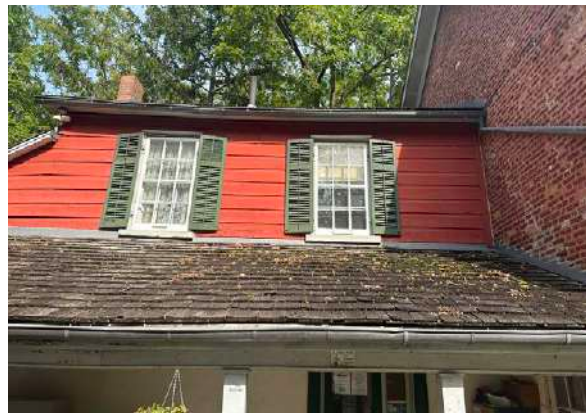
The cedar shingle roof of the 1888 Addition verandah appears to be partially covered with moss, indicating prolonged exposure to moisture. It is likely that the shingles in this area have experienced accelerated decay and will need early replacement. The moss growth should be removed from roof the affected area to allow for the shingles to dry out. Due to the prone condition and state of the roof a replacement of cedar shingle roof should be considered within 5-10 years. (Item 24)

Moss seen on 1888 addition verandah cedar roof.

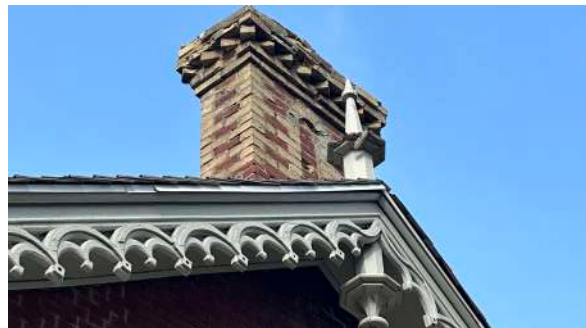
The wood finials at the north and south gable ends show advanced deteriorations. Some wood elements have detached. The barge boards at the south gable end show localized splitting. Local wood repairs and repainting of the finials and barge boards should be performed to prevent further disintegration. (Item 23)

Wood finial at south gable.

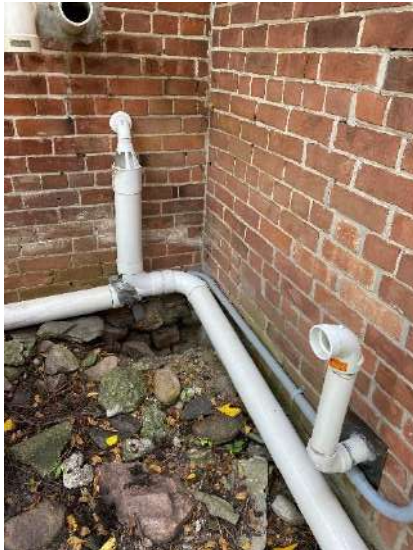
- 5.4. Rain water leaders appear to be welded steel construction capturing water from the roof and directing to grade level. Most rain water leaders terminate into PVC drainage piping that is directed away from the foundation. Some sections of this piping were noted to be broken.

- 5.5. The PVC drainage system at the exterior is a higher risk of freezing as no insulation and/or heating cables were noted. The installation of heating systems can reduce the risk of cracked piping and ensure that even in winter drainage water move away from the foundation.
- 5.6. The use of galvanized steel drainage piping is recommended; this can be selected to match the existing piping (and painted to suit) complete heat tracing to reduce the risk of ice damage.
- 5.7. We assume that smaller repairs and/or replacement of broken sections of piping to be carried out as needed; the current broken sections of piping should be replaced now to avoid water pooling near the foundation walls.
- 5.8. Refer to the Mechanical Systems Summary table for additional information on the systems.

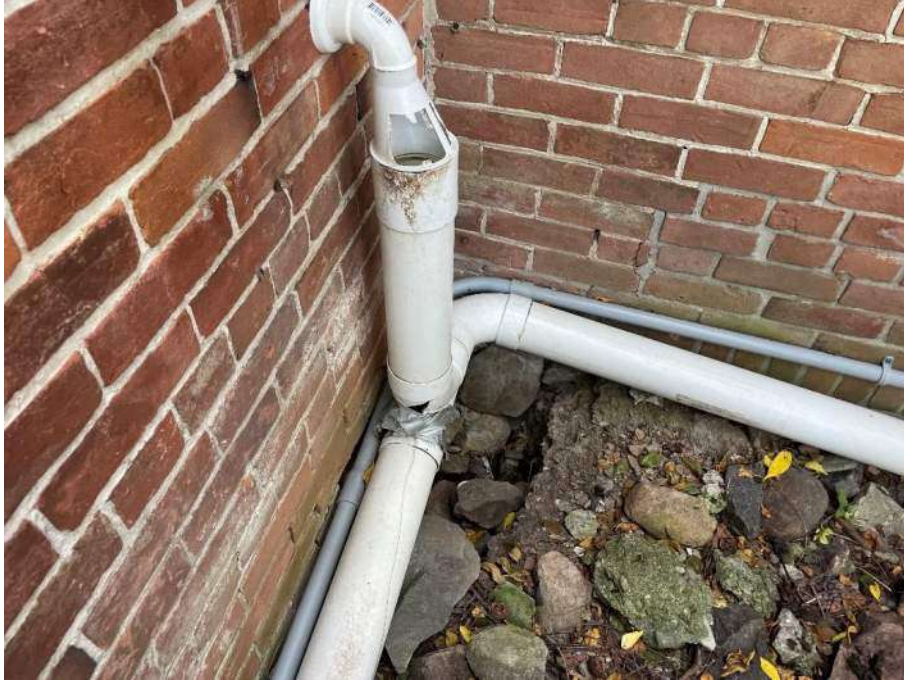
Photo 1: Damaged downspout hard piping.

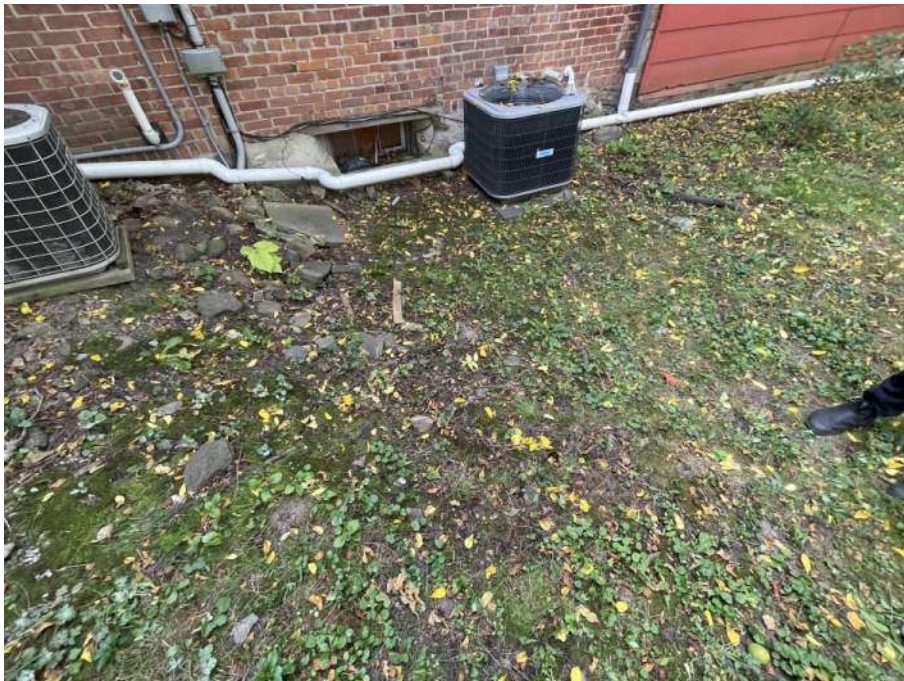
Photo 2: Adjacent grading (typical at multiple locations)

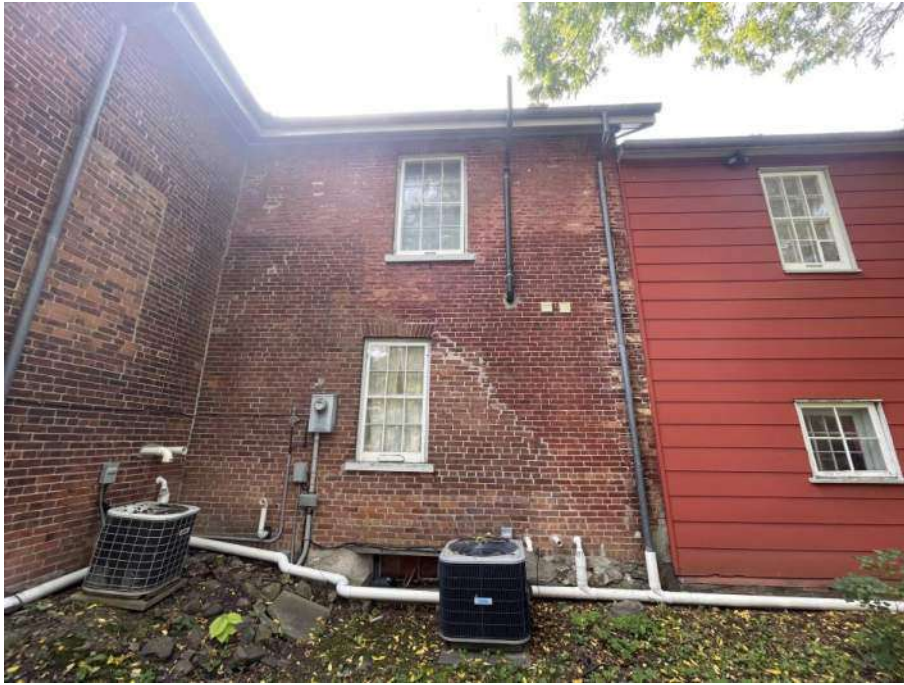
Photo 3: Cracking double brick wall

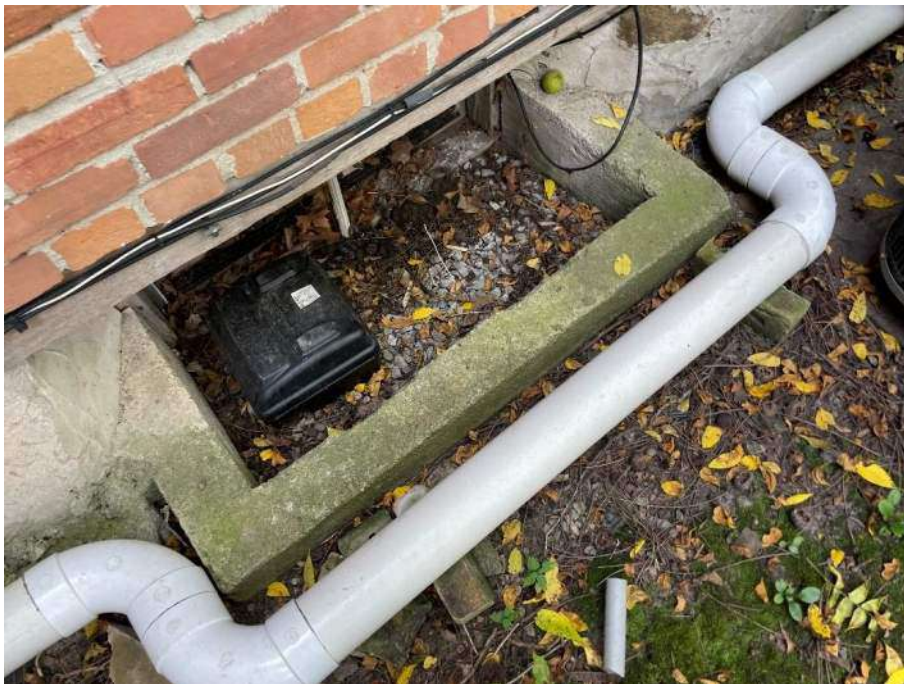
Photo 4: Improper water management at window well

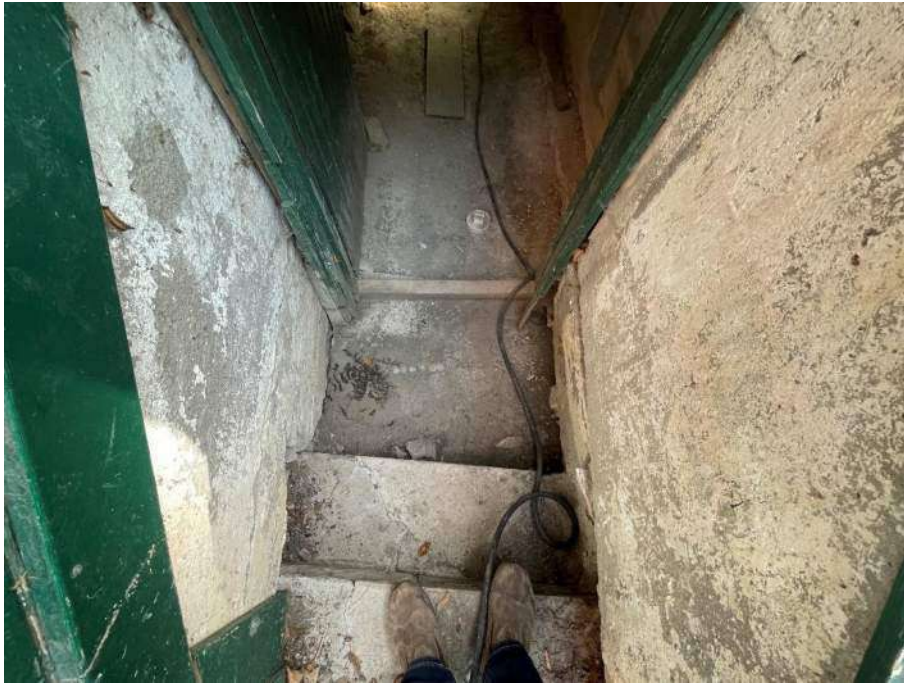
Photo 5: Missing drain at base of walk-up stairs

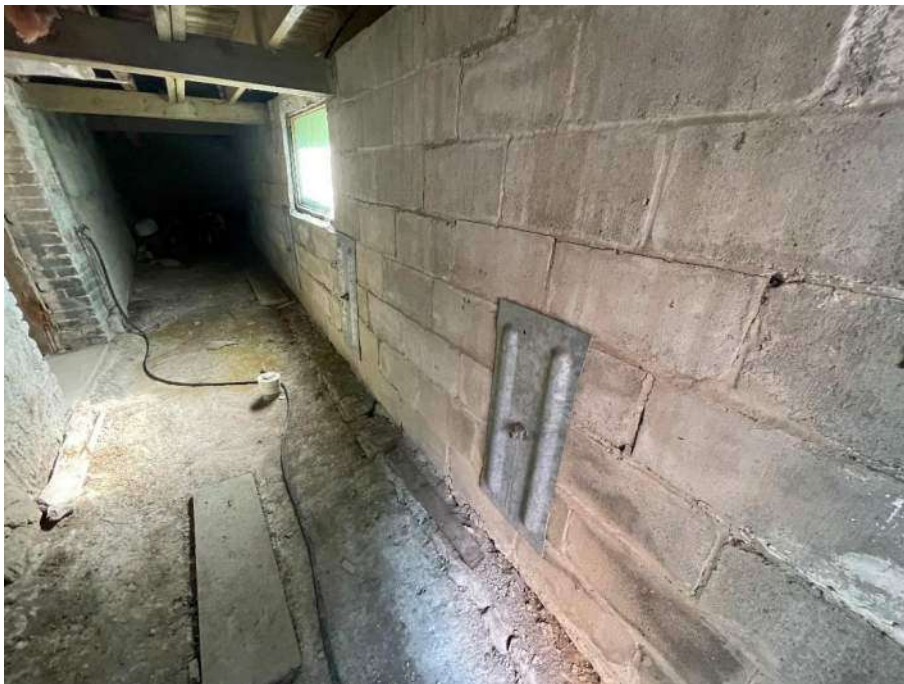
Photo 6: Previous repairs to south foundation wall

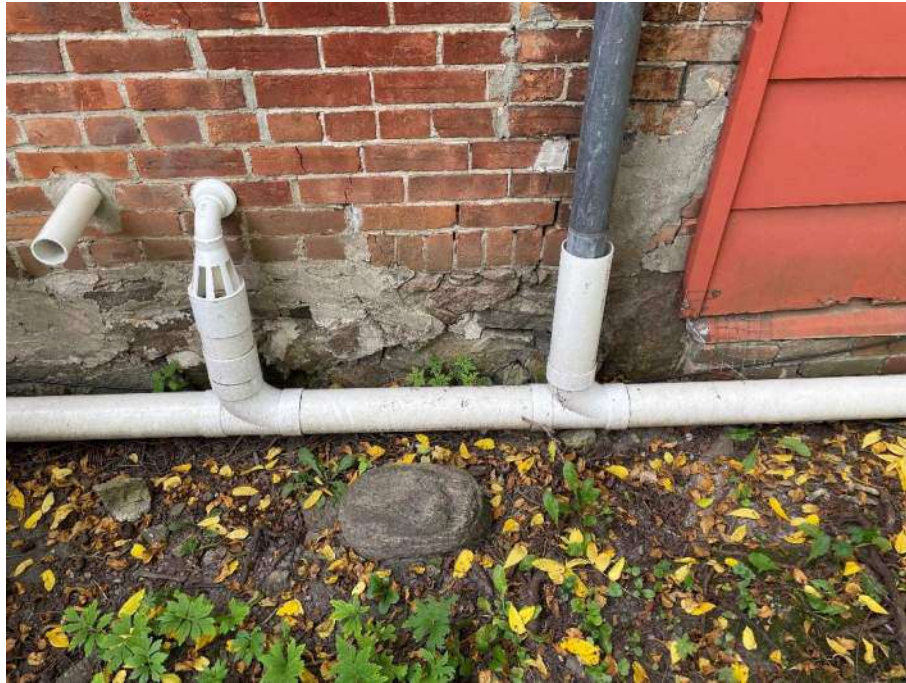
Photo 7: Phase 3 construction appears to be slab on grade.

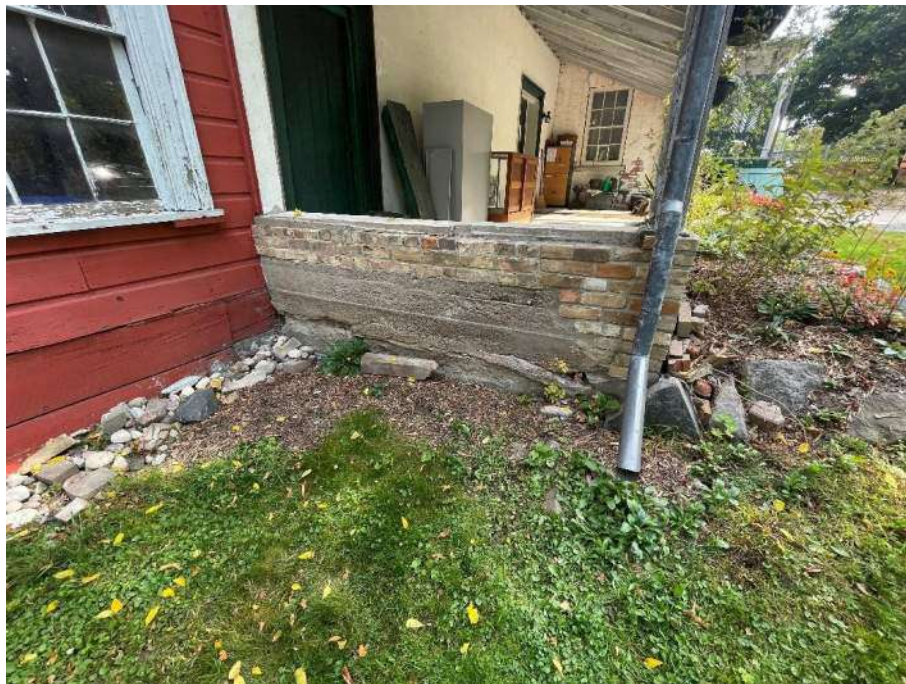
Photo 8: Phase 3 porch slab on grade without proper frost protection

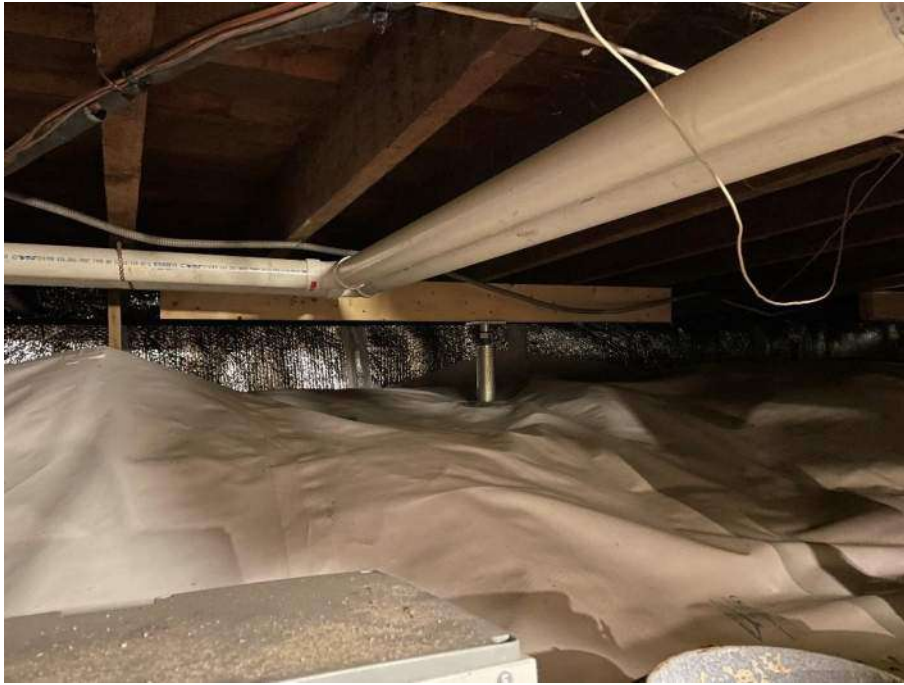
Photo 9: Over spanned floors in basement (Phase 1) – temporary supports added
