**SPECIAL MEMBERS' MEETING**

**Wednesday, February 28, 2024 at 7:00 pm**  
**Meeting held at Hillary House NHS**  
**and Virtually via Zoom**  
**MINUTES**

## **CONDITION ASSESSMENT REPORT**

# HILLARY HOUSE

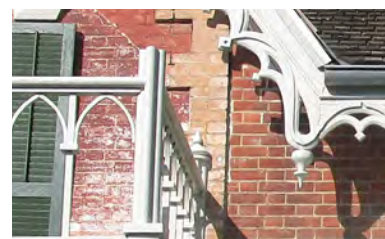
Masonry on the east elevation is in generally good condition. Mortar joints are relatively intact, and there are few damaged brick units. There are several local areas for selective repointing of joints, and a small number of damaged brick units that could be replaced. Exterior woodwork is either newly restored or in good condition, and new lead coated copper flashings have been installed.

Brick masonry at the east elevation (ERA, 2017).

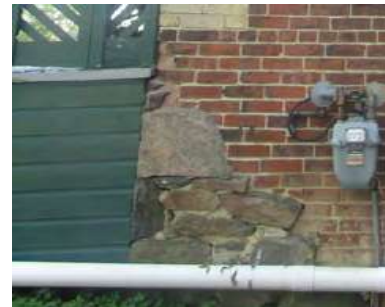
Keying of field stone and brick at base of west elevation. (ERA, 2017).

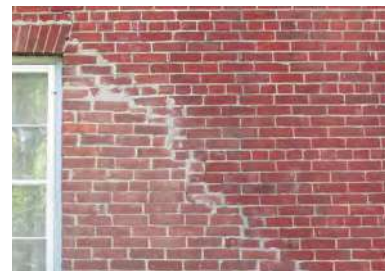
Similar to the south elevation, the masonry at the north of the 1869 addition is in poorer condition than that at the original house, but the condition of the brick is better than at the south, as this wall has received less foundation disturbance over its history. It has been visibly modified, however, where a second story opening was infilled and a slightly offset window introduced in the ballroom. This infilled area marks the top of a large step crack that runs down toward the west portion of the wall, some of which has been repaired with an unsympathetic cement based mortar. The condition of the mortar in general on this wall is fair, with some local areas exhibiting missing or deteriorated mortar in the joints. Minor holes are scattered along the wall closer to grade, and there are a number of spalled units at the upper part of the wall. While much of the foundation wall at this elevation is unexposed, the visible portion at the west side of the wall displayed significant deterioration, with a total loss of mortar in multiple locations. The settlement in this area is likely contributing to the structural cracking observed up the wall to the east. The condition of the rear kitchen addition will be discussed in a separate section.

Portland cement repair of step crack-ing at north elevation (ERA, 2017).

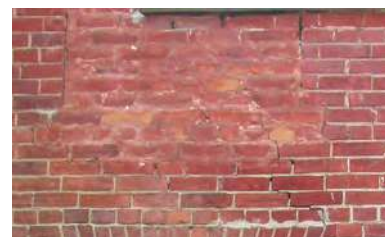
Base of infilled door at north elevation, with step crack visible. (ERA, 2017).

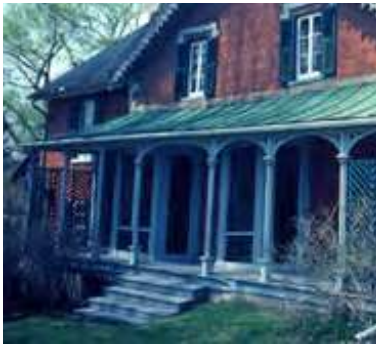
Portion of north veranda where firmness issues are present (Parks Canada).

The veranda at the north was also subject to framing upgrades as part of the 1980s conservation work, including new ledger boards, posts and decking. There has been some deflection reported in floorboards of this portion of the veranda, but it does not have the same close relationship with the ground plane as the east veranda, meaning that migration of ground moisture to the floorboards is less of a possibility. The floor deck is situated well over a foot above grade at most portions of the north veranda, and there appears to be sufficient drainage away from the structure. To assess the causes of the deflection further, an investigation underneath the north veranda floor should be conducted - access for this was not available at the time of review.

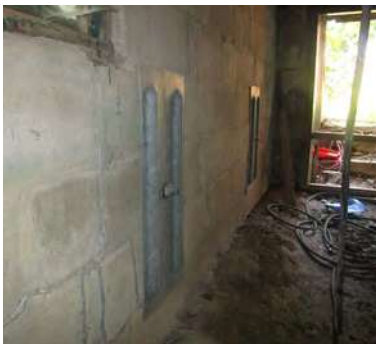
Steel plates installed to reinforce block wall under south veranda. (ERA, 2017).

In addition to the areas reported above, there was also minor deflection observed in the floor at the top of the south veranda stairs. The joists in this area received reinforcement with new beams during previous remedial work, in addition to new decking and ledger boards, as at the east. The concrete block wall at the edge of the veranda in this section (which is also the sidewall of the passage underneath the veranda) was noted as being deteriorated in a 1999 structural assessment report. The wall has subsequently been repaired and reinforced with steel plates and anchor rods to assist in the retention of the soil beyond. The crawl space passage underneath this section of the veranda provided an opportunity for review of the underside of the porch structure. While the condition of the wood framing and repaired block wall appeared good, it is possible that the settlement and subsequent remediation of the block wall caused a loss of fit or alignment in some of the wood structural members, contributing to a lack of firmness in the decking. Worthwhile to note is the span of the floorboards in the area of the veranda at the top of the stairs. While Morrison Hershfield's 1980 structural drawings show existing double floor joists at a maximum of 21" spacing in this area, the floorboards as observed are spanning over 30" from the south masonry wall to the mid span joist. This large span may be contributing to the firmness issues at the porch in this area.

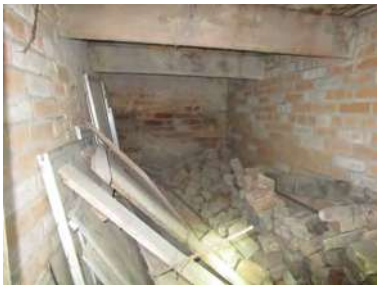
Interior of central crawlspace under rear kitchen addition. (ERA, 2017).

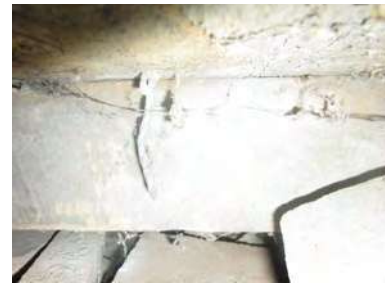
The floor surface at the interior of the rear summer kitchen addition is irregular, and exhibits gaps and discontinuities. While deflection and deterioration were observed, it is difficult to know if these local conditions can be attributed to a compromised primary floor structure beneath, or to the deterioration of the various layers of built-up flooring that have been applied on top. A photograph taken from a gap underneath a section of plywood subfloor reveals that 2x4" sleepers have been laid (north-south) across an irregular joist fabric below.

Underside of rear kitchen addition flooring, showing wood sleepers resting on irregular joist fabric. (ERA, 2017)

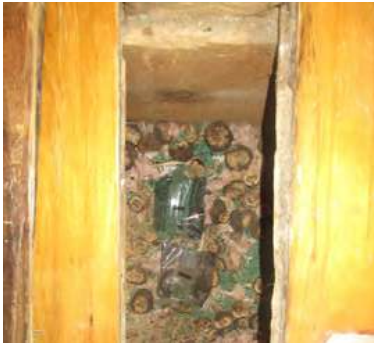
The AHS has reported animal infestation throughout the house. Specifically this has included noises of animal movement behind the finishes at the ground floor of the 1888 addition (the present office), as well as the presence of shells and other discarded food items in parts of the house, notably in the floor cavity at the second floor historic washroom.

Cavity in historic washroom floor showing evidence of animal infestation. (ERA, 2017)

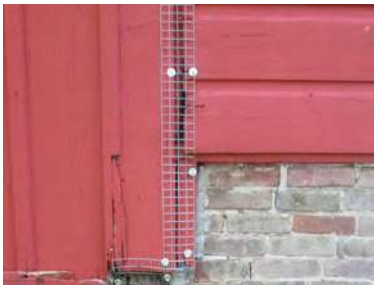
Typical repairs to building fabric to prevent entry of animals. (ERA, 2017).

Judging by the exterior review, much effort has been undertaken to prevent the access of animals into the house. Holes, cracks and gaps in the wood siding, masonry walls, foundations, and roof soffits and eaves have been filled, or more often covered with a wire mesh. This has succeeded in barring the most obvious points of entry, but several additional potential access points were identified during the visit

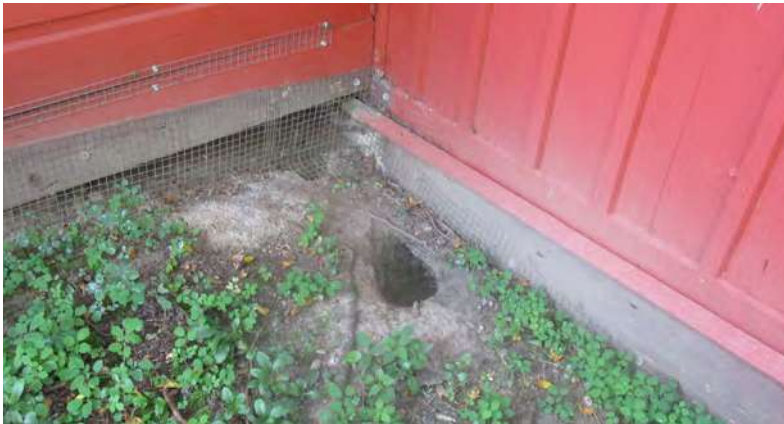
Evidence of burrowing animals under floor structure of rear kitchen addition at north elevation. (ERA, 2017)

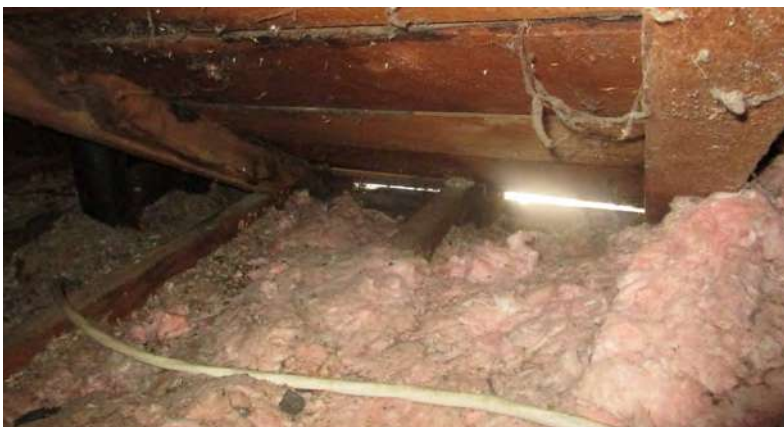
Animals may also be entering the fabric of the 1888 addition area through the eaves of the roof. Upon inspecting the attic at the top of this addition, it was observed that the batt insulation at the ceiling joists was disturbed, especially at the eaves, and there was some evidence of animal traffic. As there was a considerable amount of daylight visible in the attic at the eaves, it is assumed that there may be unchecked points of entry about the perimeter.

Area of potential animal entry at eaves of 1869 addition roof, showing disturbed batt insulation at assumed entry point. (ERA, 2017)

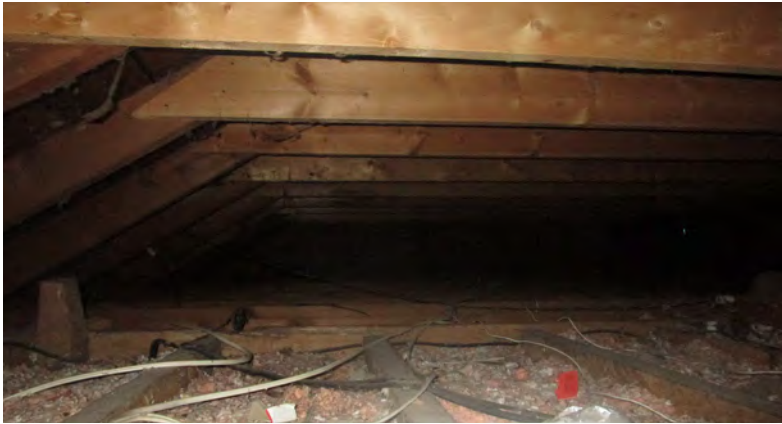
Interior of eastern (main house) attic, with tie reinforcement, wiring, and blown in insulation shown. (ERA, 2017).

The eastern attic (above the main house) displayed sound framing. There is evidence of previous remediation in the form of additional wood roof ties installed across the structure, as well as additional vertical members supporting the ridge. There is approximately 3-4" of blown in batt insulation between the ceiling joists, having likely settled from an original 6" application to fill the depth of the 2x6" joists. A fair amount of wiring was visible across the attic. Older knob and tube wiring is visible, although it has been cut off. Two roof vents were observed. Overall, this attic area appears dry, and there was no visible evidence of water penetration.

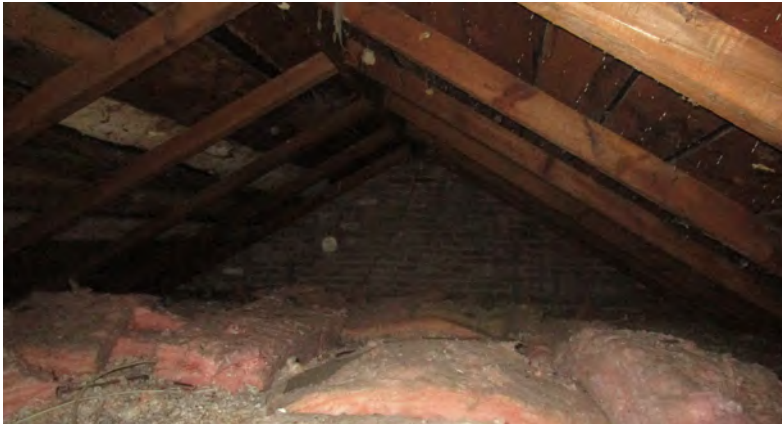
Interior of western (1869 addition) attic, showing framing, and multiple layers of insulation. (ERA, 2017)

The western attic and roof (above the 1888 addition) has not received the same framing remediation as the eastern roof. Though there was no significant deterioration visible in the structural members, this roof has no ties or braces for reinforcement, and displays relatively light 2x4" rafter construction. Generally, the wiring in this attic seems to be in good condition, but there are some areas where wires are kinked, and there are some areas of electrical tape repair to the wiring. There is evidence of water penetration at the western gable, where discoloration of the wood sheathing and framing is visible. While this may still be occurring, it is perhaps not a regular or severe enough issue to cause rot and deterioration yet. It is noted that this area is directly beneath the western chimney of the 1888 addition. The penetration of water here may be due to inadequate, missing or damaged flashing about the chimney base. At the attic floor, an additional layer of batt insulation has been applied over an initial layer of blown-in insulation. It was noted that the batt insulation has been disturbed throughout, and particularly pulled away from the eave area, suggesting animal access and habitation. As described in the previous section, there was a significant amount of daylight visible at the eaves, where there could be unsealed openings allowing animal access.

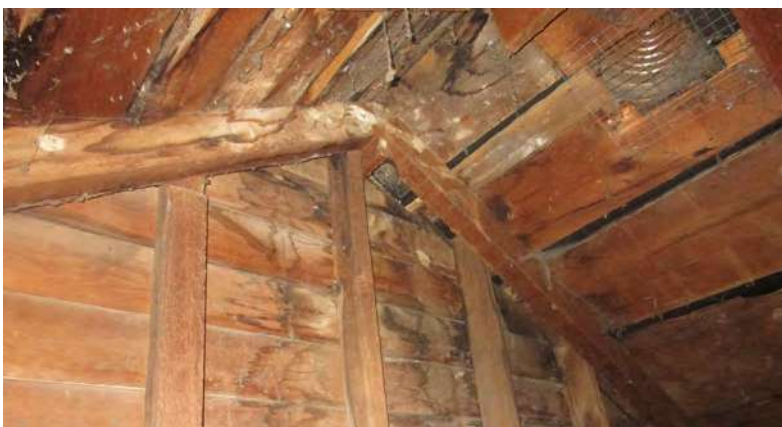
Area of water penetration at west gable of western attic. (ERA, 2017)

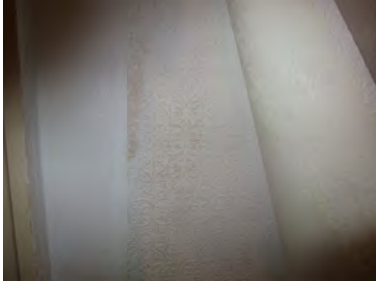
Delaminating wall paper at second floor bedroom (now gallery). (ERA, 2017).

The historic wallpaper at the second floor bedrooms of the main house is in varying states of repair and deterioration. The wallpaper at the Master bedroom (at the south-east) is the most intact, with the majority still in place. Some portions of this wallpaper (likely deteriorated) have been removed, while others have been repasted and secured. The resulting appearance of the wall is patchy and incomplete, but does not display much new deterioration. The wallpaper in the nursery (at the south-west) is in considerably worse condition, and shows evidence of moisture damage, peeling, and delamination. The coverage of the original wallpaper is also sparser in this room, and not as much repair has been undertaken. The most intact section of this wallpaper was found in the closet of this room. It should be noted that this room is currently being used for storage purposes, and thus has not undergone as much restoration work as the historic master bedroom, which is considered part of the museum space. At the north-east bedroom (currently being used as an exhibition space), there has been newer wallpaper applied over the existing wall surface. There is, however, an issue with the adhesion of the new wallpaper to the existing wall surface, which has resulted in the delamination of some sections of wallpaper. Also of note is a small section of the wall where an underlying, older portion of wallpaper (in a different style) was preserved, exposed, and covered with plexi-glass.

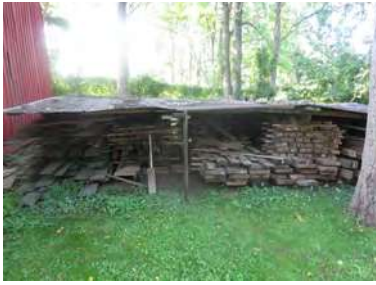
Current Storage Arrangement for disassembled McIntyre Coach House.  
(ERA, 2017)

weighed down with stones. Close inspection of the components reveals that they are stored fairly systematically, with joists, rafters, cladding, and other building elements stacked in separate parts of the storage area. It was also noted that many of the components had tags attached to them, presumably with identification information necessary for reconstruction. It is not known whether there is a set of drawings which to which these tags are keyed.

While the coach house components appear to be dry, free of rot, and in generally good condition, their mode of protection could be inadequate for longer term storage. The historic building components are too close to the ground, and the migration of ground moisture into the wood is a concern. Additionally, the open sides of the enclosure, underneath the sheet metal covering, allow for blowing snow and driving rain to infiltrate the storage area, which could lead to moisture damage.

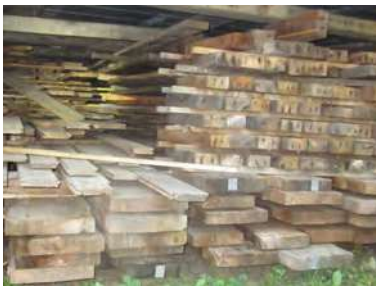
Detail of stacked Coach House components showing organization and tags.  
(ERA, 2017)

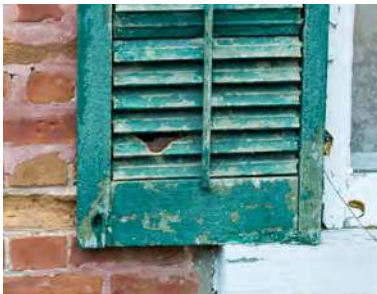
Any animals should be removed and the shutter and masonry repaired. (Hillary House National Historic Site, 2017).

7. Review exterior walls of 1888 addition, rear summer kitchen addition and masonry house for openings, holes and points of animal entry. Patch and repair as required. Consult animal control company to remove pests.

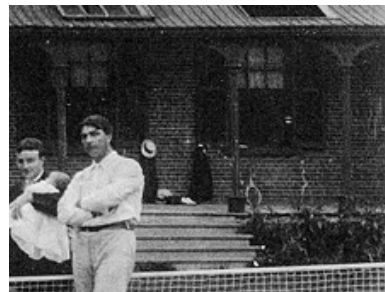
North veranda staircase to be restored. (AHS).

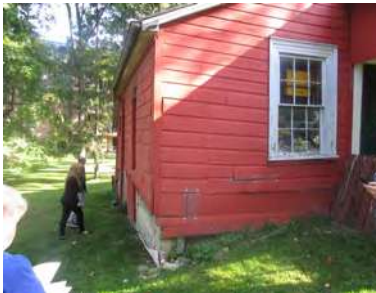
Rear summer kitchen addition.  
(ERA, 2017).

The other area of the house which could be considered to be at a high level of priority is the rear summer kitchen addition. This portion of the structure suffers from foundation issues and has significant

distortion in its framing and deterioration in its finishes, resulting in a space that can only be used as storage. An attempt could be made to stabilize the structure with additional foundation supports and framing improvements, and it could be left as a non-insulated storage space. This could be an expensive undertaking for the amount of benefit to museum, and could also be impossible to achieve given the state of the structure. The rear summer kitchen addition could also be simply left as is, in which case further deterioration and possible collapse must be expected. As recommended, it could also be rebuilt as an insulated addition to the main house, on new foundations, potentially with an enlarged consolidated footprint.

7. Dismantle and rebuild summer kitchen structure. Salvage existing wood cladding and sheathing for reuse. Provide new wood cladding for lower 3 courses of cladding, new wood shingle roof, new interior wood plank subfloor, foundation repairs and foundation infill. Ensure crawl space is ventilated.

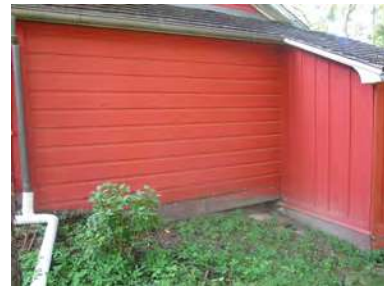
Rear summer kitchen addition.  
(ERA, 2017).

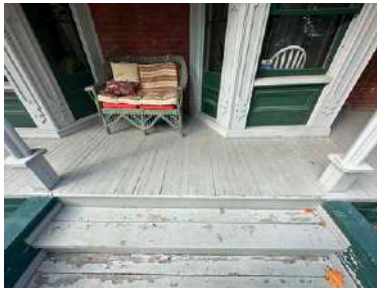
Deficient paint work at exterior west veranda stairs.

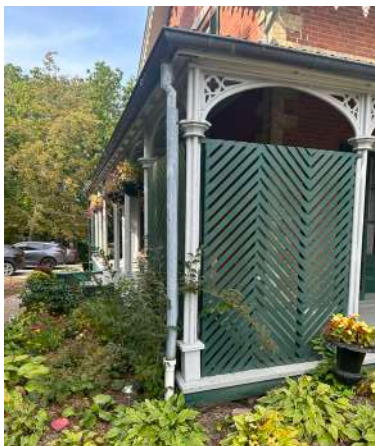
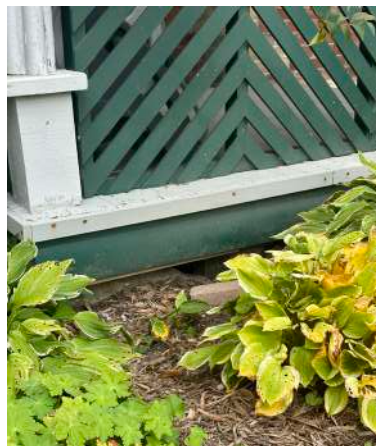
Active animal Ingress routes through the verandah south-east corner. (ERA, 2023)

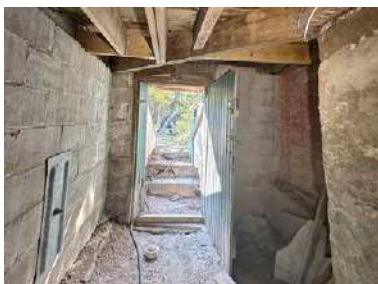
One of 2 capped off drain pipes under south verandah crawl space.

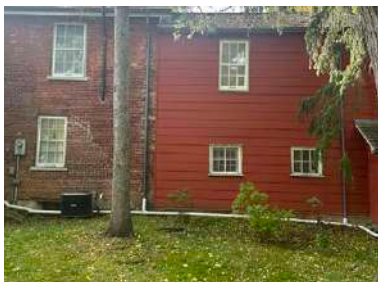
PVC rain water pipe collecting water from 5 rainwater leaders.

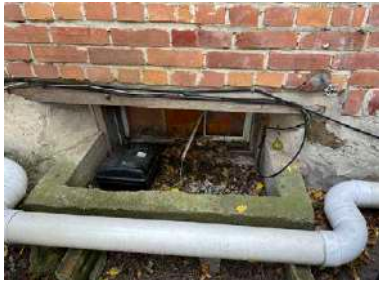
1869 addition north elevation window well with broken window.

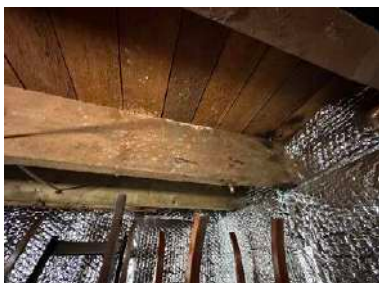
Basement waterproofing concealing masonry wall

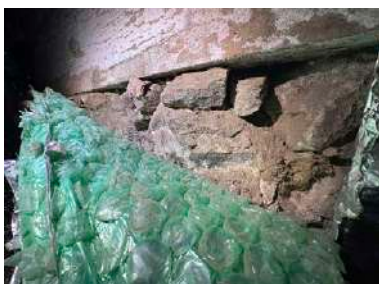
Uncovered, deteriorated fieldstone foundation under waterproofing in basement.

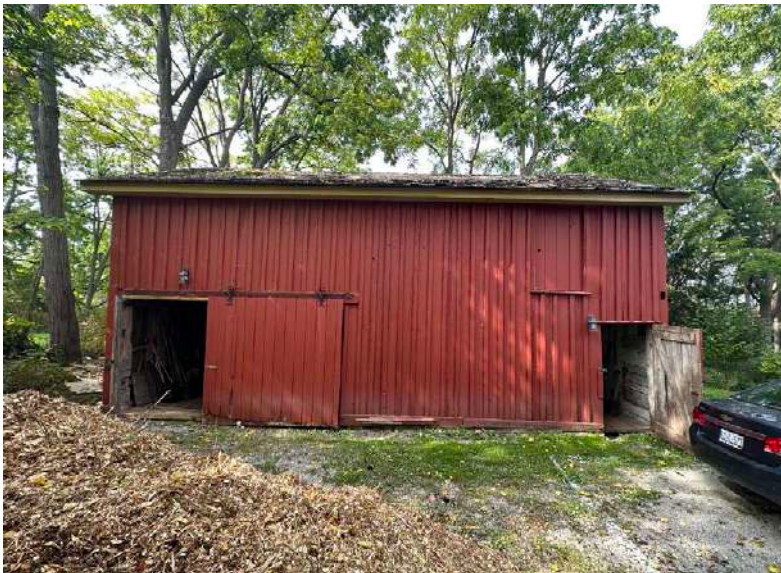
An in-depth assessment of the Hillary House barn was not undertaken for the 2017 Condition Assessment Report. Although an investigation of the barn is not part of this report, the consultant team undertook a brief review and found that the wood structure contains significant deteriorations at grade and is no longer properly supported. The ERA and Eternity opines that the barn is at its state not fit to be used for occupancy or storage. It is advised to remove all storage from barn and cease use of barn until a detailed condition assessment be done by a structural consultant and heritage consultant. (refer to attached structural assessment report by Eternity Engineering)

Hillary House Barn.

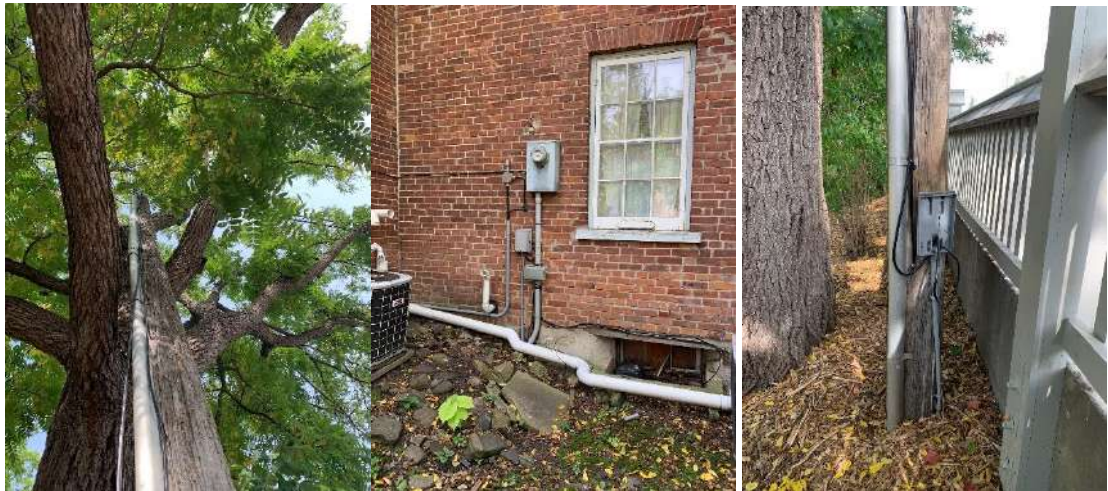
Main electrical panel is located at the north side of ground floor and is a 120/240V, 200A Square D load center with 40 spaces. Panels appear to be in fair condition and without space for new breakers. Panel schedule needs to be prepared/updated.

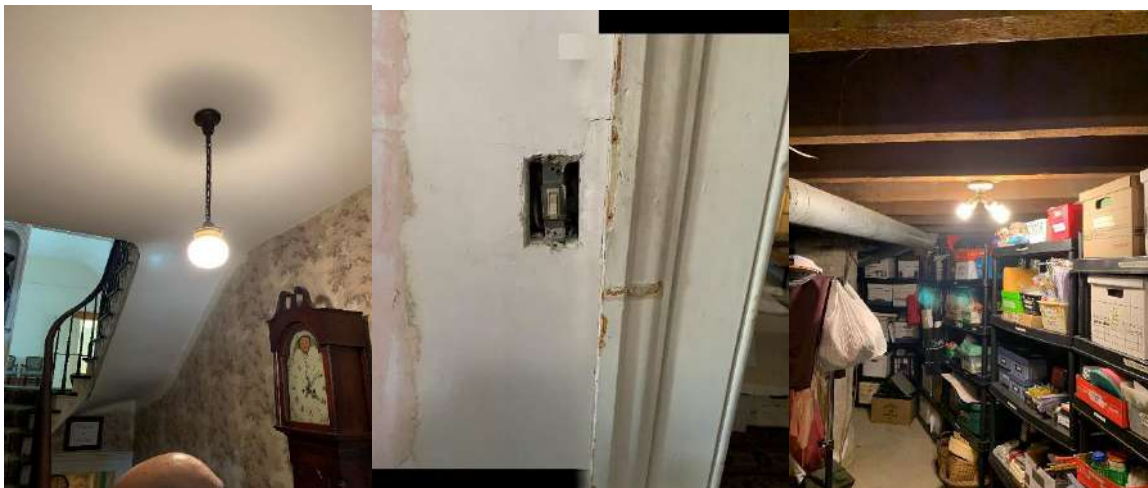
- 4.1. The lighting system of building appears to be replaced /renewed in different stages recently. The lighting fixtures are mix of vintage luminaires, recently replaced LED recessed downlights and looks to be in fair condition. Service rooms have LED lamps installed in low height and without protection that is recommended to be replaced with fixtures with wire cage to prevent damage.
- 4.2. Lighting switches are mostly old and in some cases are not working. They have been kept in place but the circuit has been redirected to local plugs to control the lights. Cover plates in some cases are missing

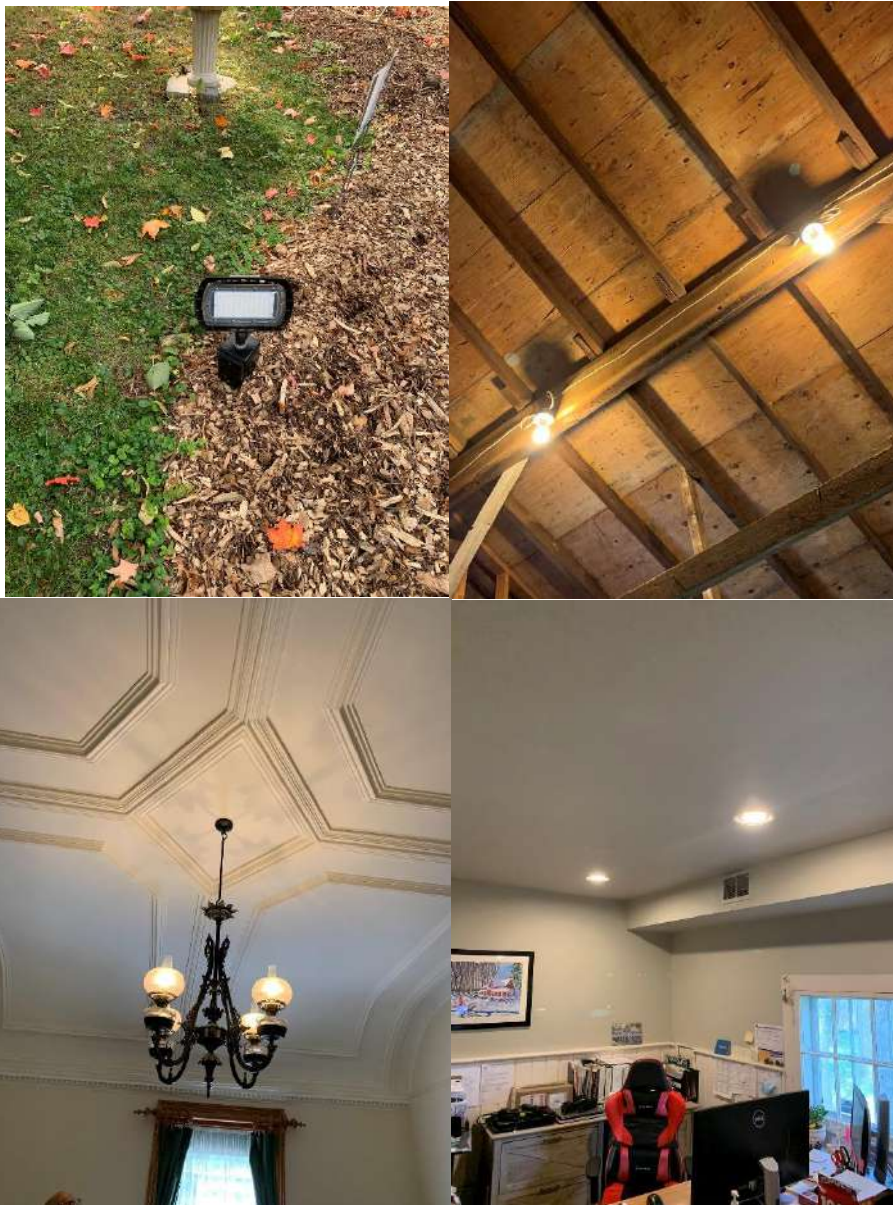
- 4.3. There is no emergency generator in the building. Emergency lighting system is based on batteries and local remote heads located in corridors and stairs. Emergency lighting needs periodic inspection to ensure batteries are in good shape and will provide enough duration of power when required. Two service rooms in basement and stairs do not have sufficient emergency light.
- 4.4. Outdoor lighting is LED flood light and looks to be installed recently and controlled via time clock.

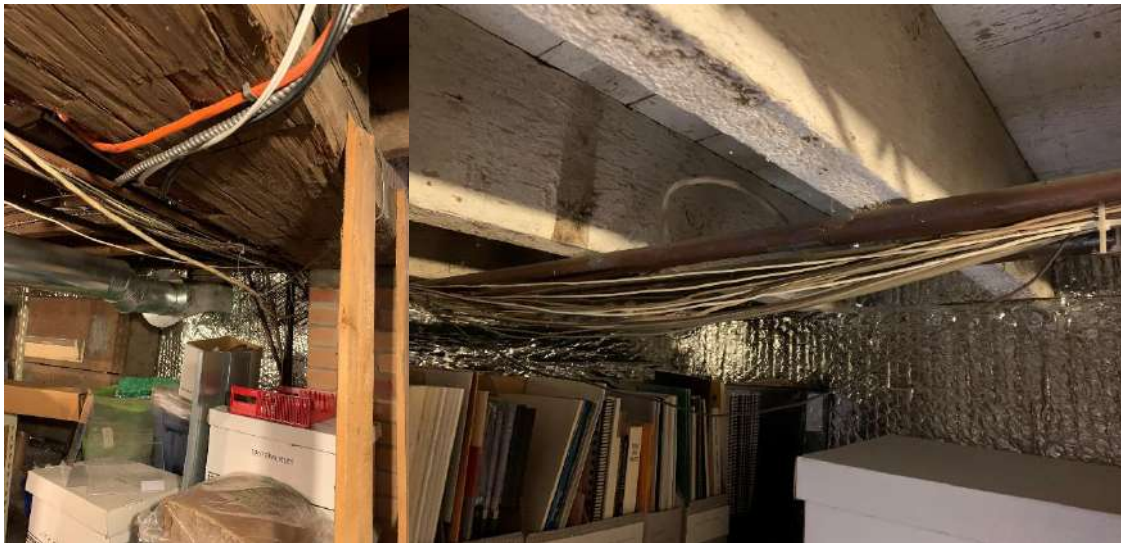
- 5.1. In general building wiring in indoor areas is concealed type. In basement service rooms and storage rooms there are some exposed wiring without proper mechanical protection in some cases. Overall wiring appears to be replaced in recent past and in fair condition.

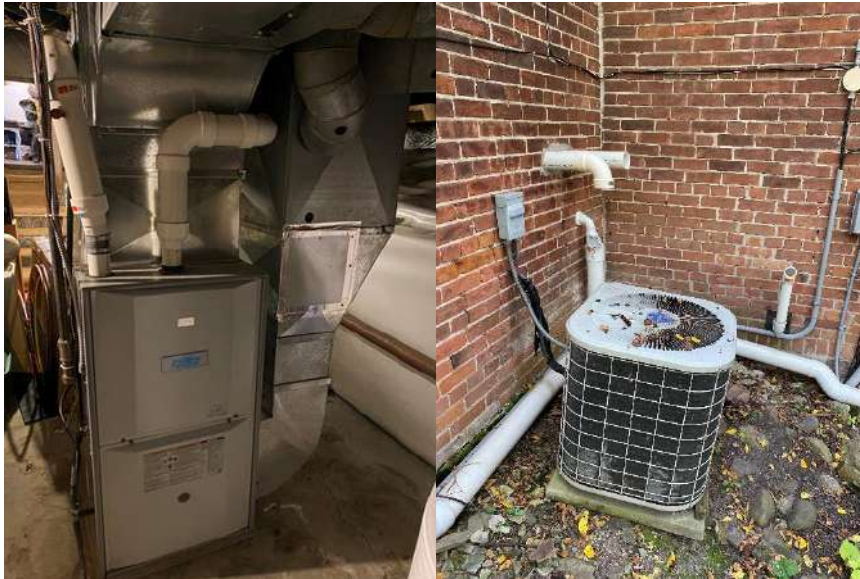
- 3.1. The building is generally heated and cooled through two independent gas fired furnaces complete with electric (DX) air conditioning units.

***East Mechanical Room Furnace and associated outdoor air conditioning unit.***

Most mechanical upgrades required are associated with end of life scenarios including the furnace and air conditioning systems. Plumbing and drainage systems have been upgraded in the past; however, drainage systems should be inspected and/or cleaned periodically.

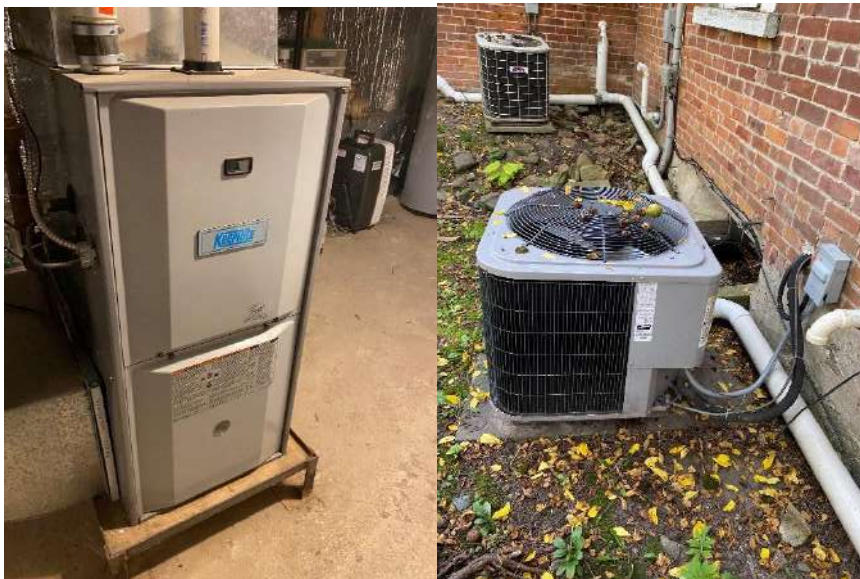
***West Mechanical Room Furnace and associated outdoor air conditioning unit.***

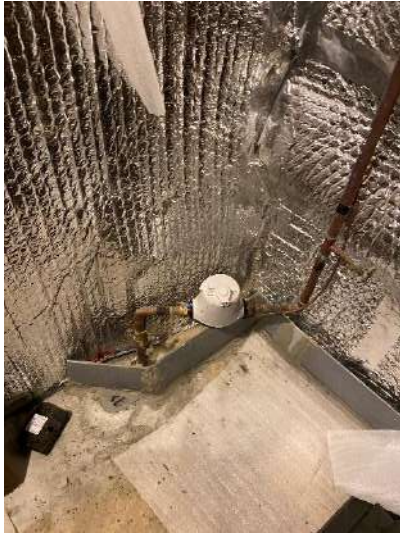
- 4.1. Domestic cold-water service enters at the east basement mechanical room with a 3/4" water service pipe.

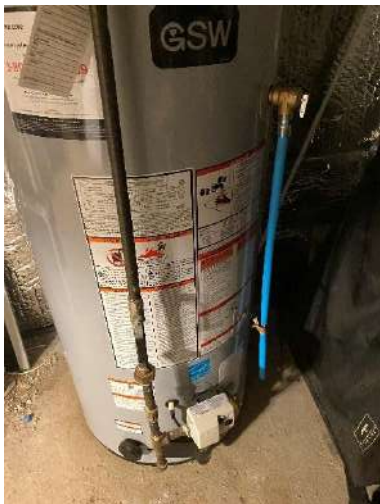
- 4.2. Domestic hot water is generated through a tank type gas fired water heater. The heater appears to be a rental from Enercare.

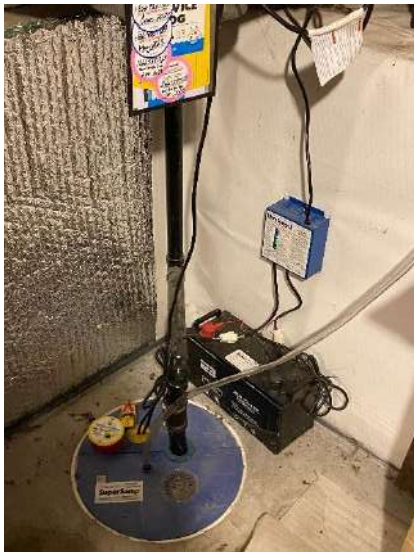
- 5.1. Where visible, most sanitary drainage piping consists of copper DWV (drainage, waste, vent) piping with bronze cast fittings. Some ABS piping was also noted. Some older cast iron piping was also noted, however, we understand this is not used (noted within 2nd floor washroom).
- 5.2. The buried sanitary piping was likely rehabilitated in 1996 as part of a project to reline 75 meters of 9-inch piping and replace 75 meters of 8-inch piping.
- 5.3. The visible sections of this storm drainage piping within the basement appeared to be PVC piping. Most piping appears to have been part of the 2016 drainage project.
- 5.3.1. In each mechanical room, a single sump pump is provided complete with prefabricated sump, controller and battery back up. This appears to have been added to address foundation/ground water issues in 2016.

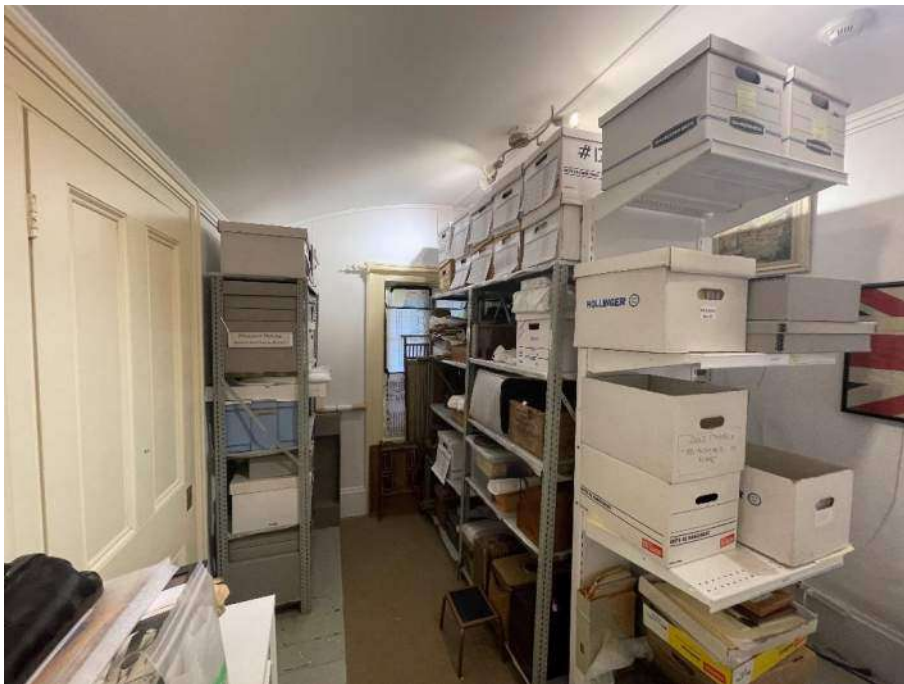
One of the rooms on the second floor is being used as a storage area (Photo 10). Storage racks and stacked boxes can quickly exceed standard floor live loads of 40 psf. Even though the area is not showing signs of cracking in the ceiling joists below, we recommend either the storage area is moved to a slab on grade within the structure, moved off site or temporary shoring is added to the structure until the storage has been addressed.

Photo 10: Stacking load on second floor

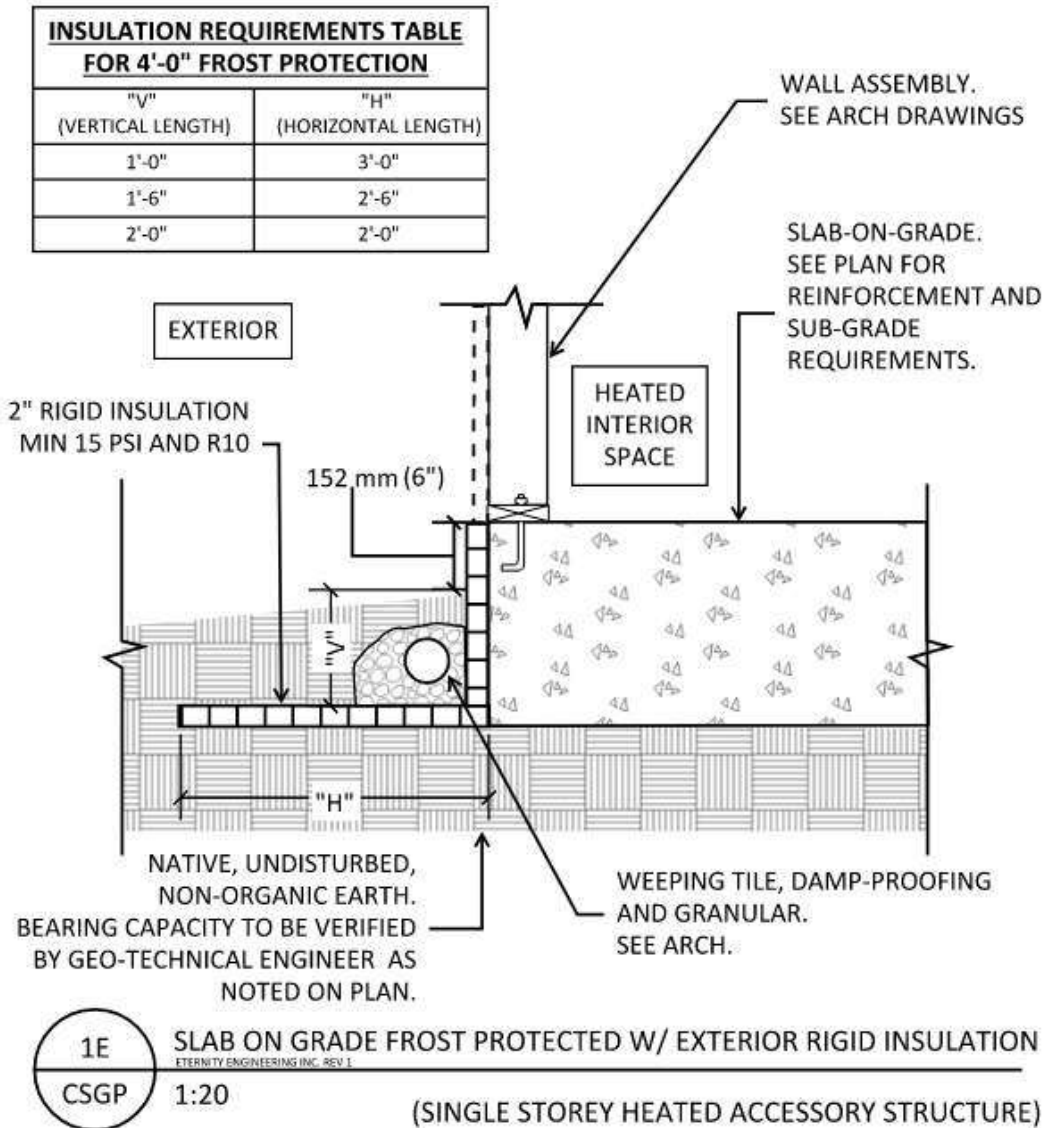
Phase 3 foundations are currently an occupied slab on grade which does not appear to be frost protected. The movement in the slab could be contributing to the cracking in the foundation wall/double wythe brick of phase 2 (Photo 7). The front porch and retaining wall for phase 3 is also poured on grade and should be remediated (Photo 8). In Ontario, the minimum frost protection is 4 feet to prevent frost movement. The remediation for this deficiency is to have the entire foundation underpinned to 4'-0" or add rigid insulation (Similar to Figure 1).

Figure 1: Shallow Frost Protection Example with Rigid Insulation for a Heated Structure.
